The Canterbury Earthquakes: The land damage and planning for the recovery process

Shannon Richardson, Senior RM Planner

Tonkin & Taylor Ltd

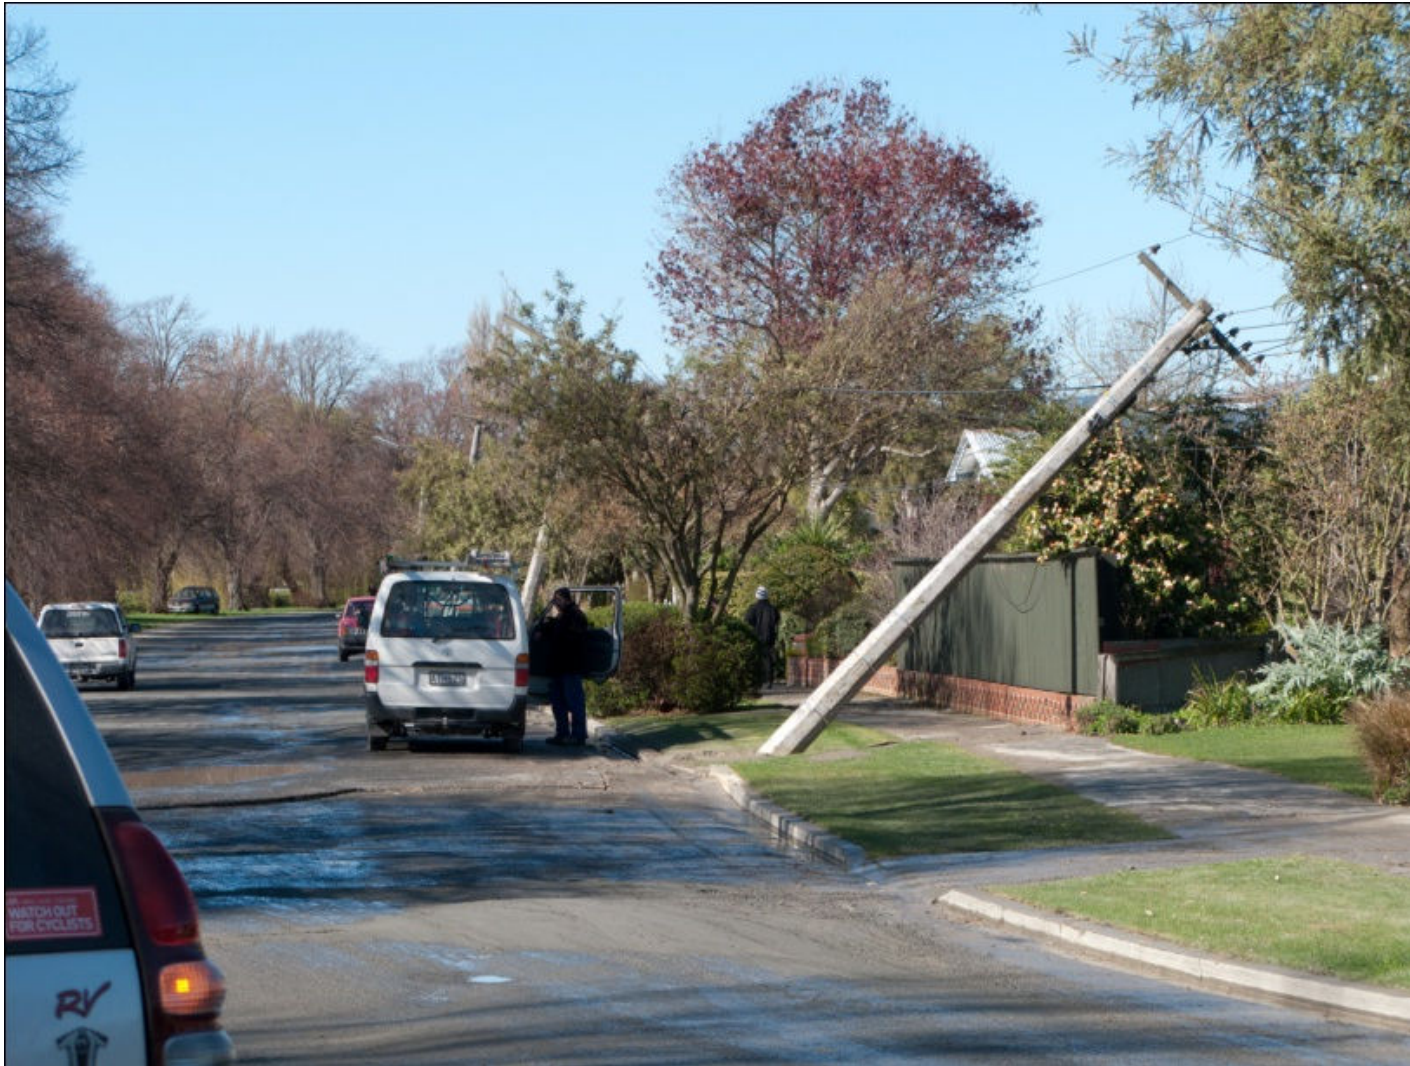
Liquefaction

sand and water ejection

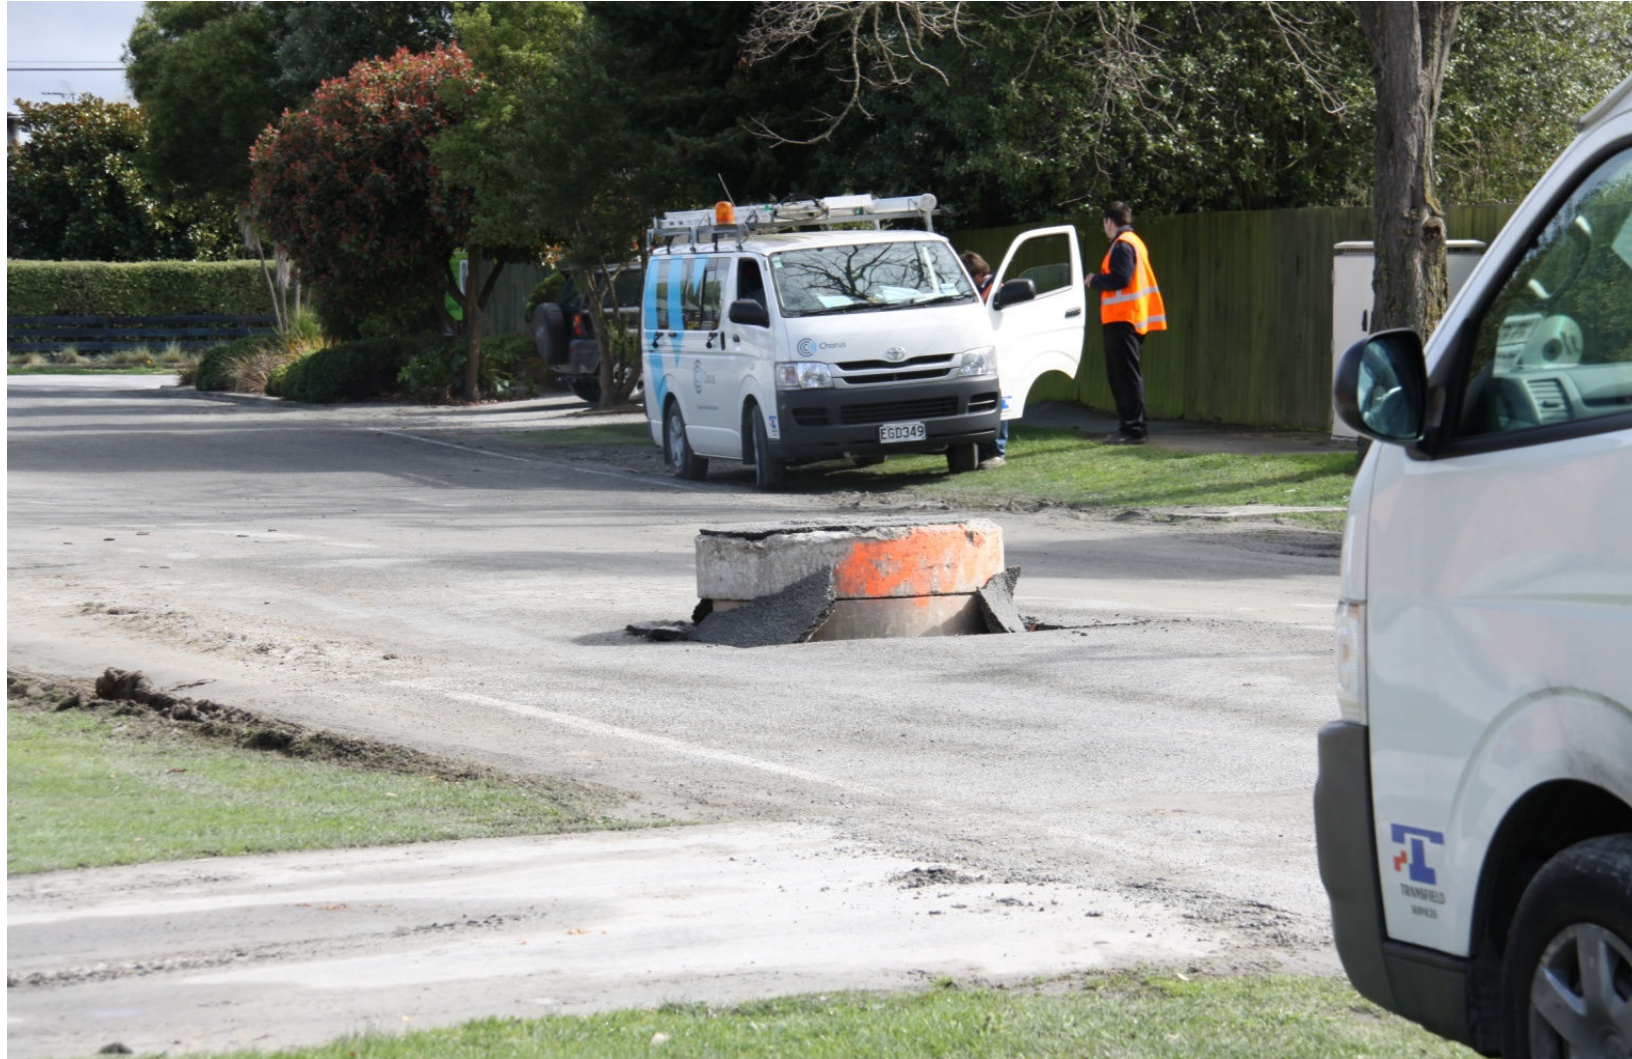
Liquefaction – uplift of manholes

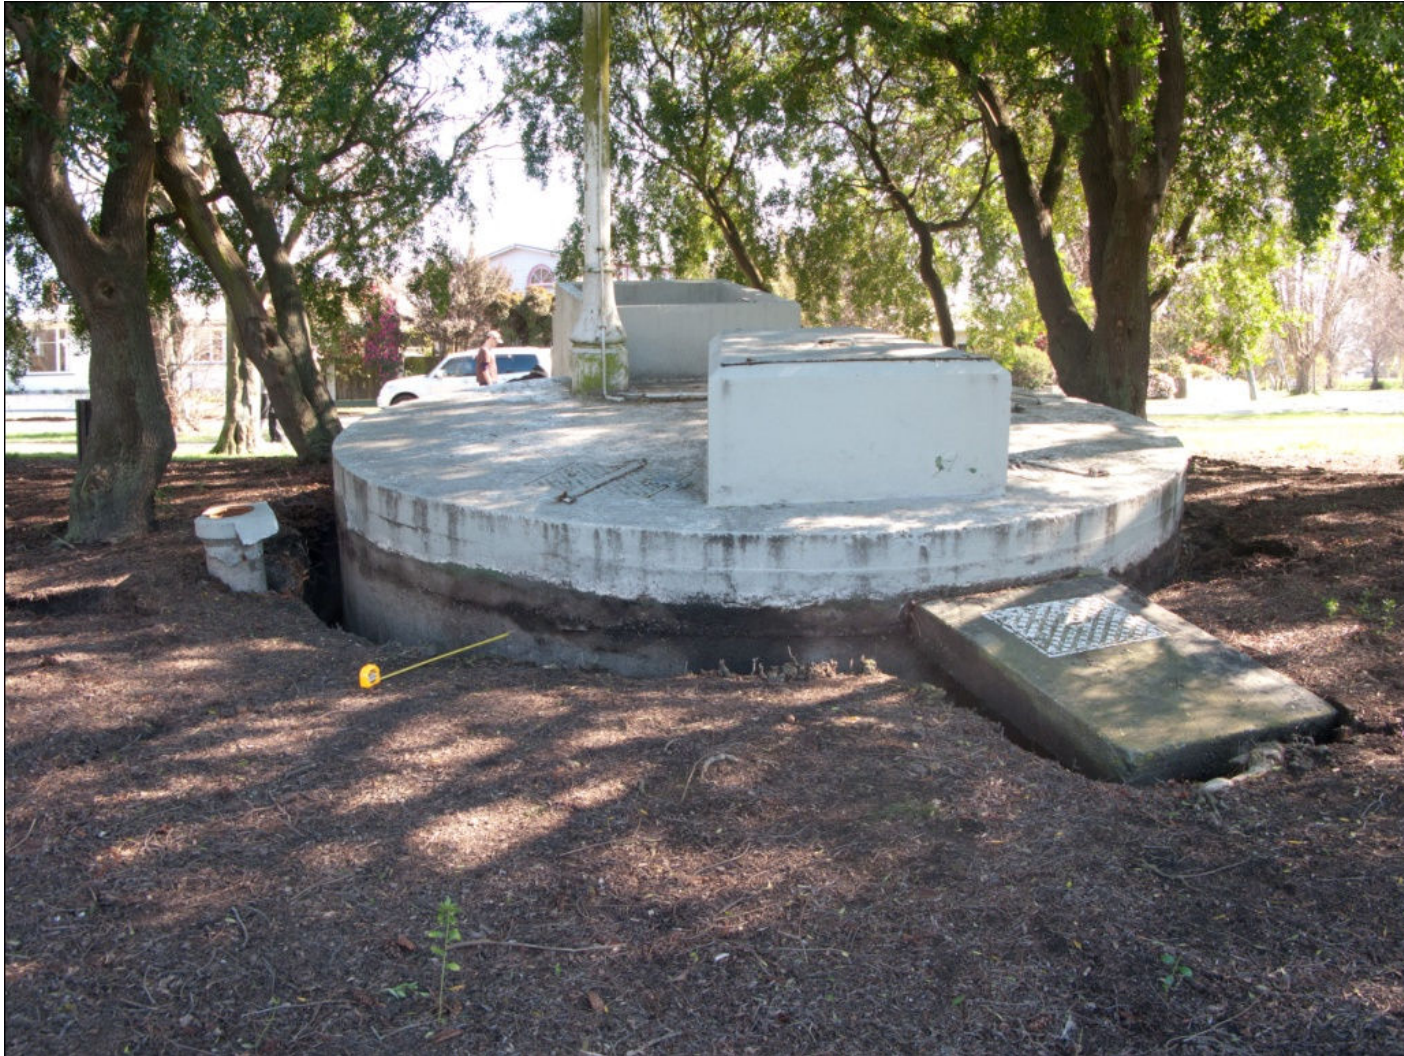
Liquefaction

uplift of pump stations

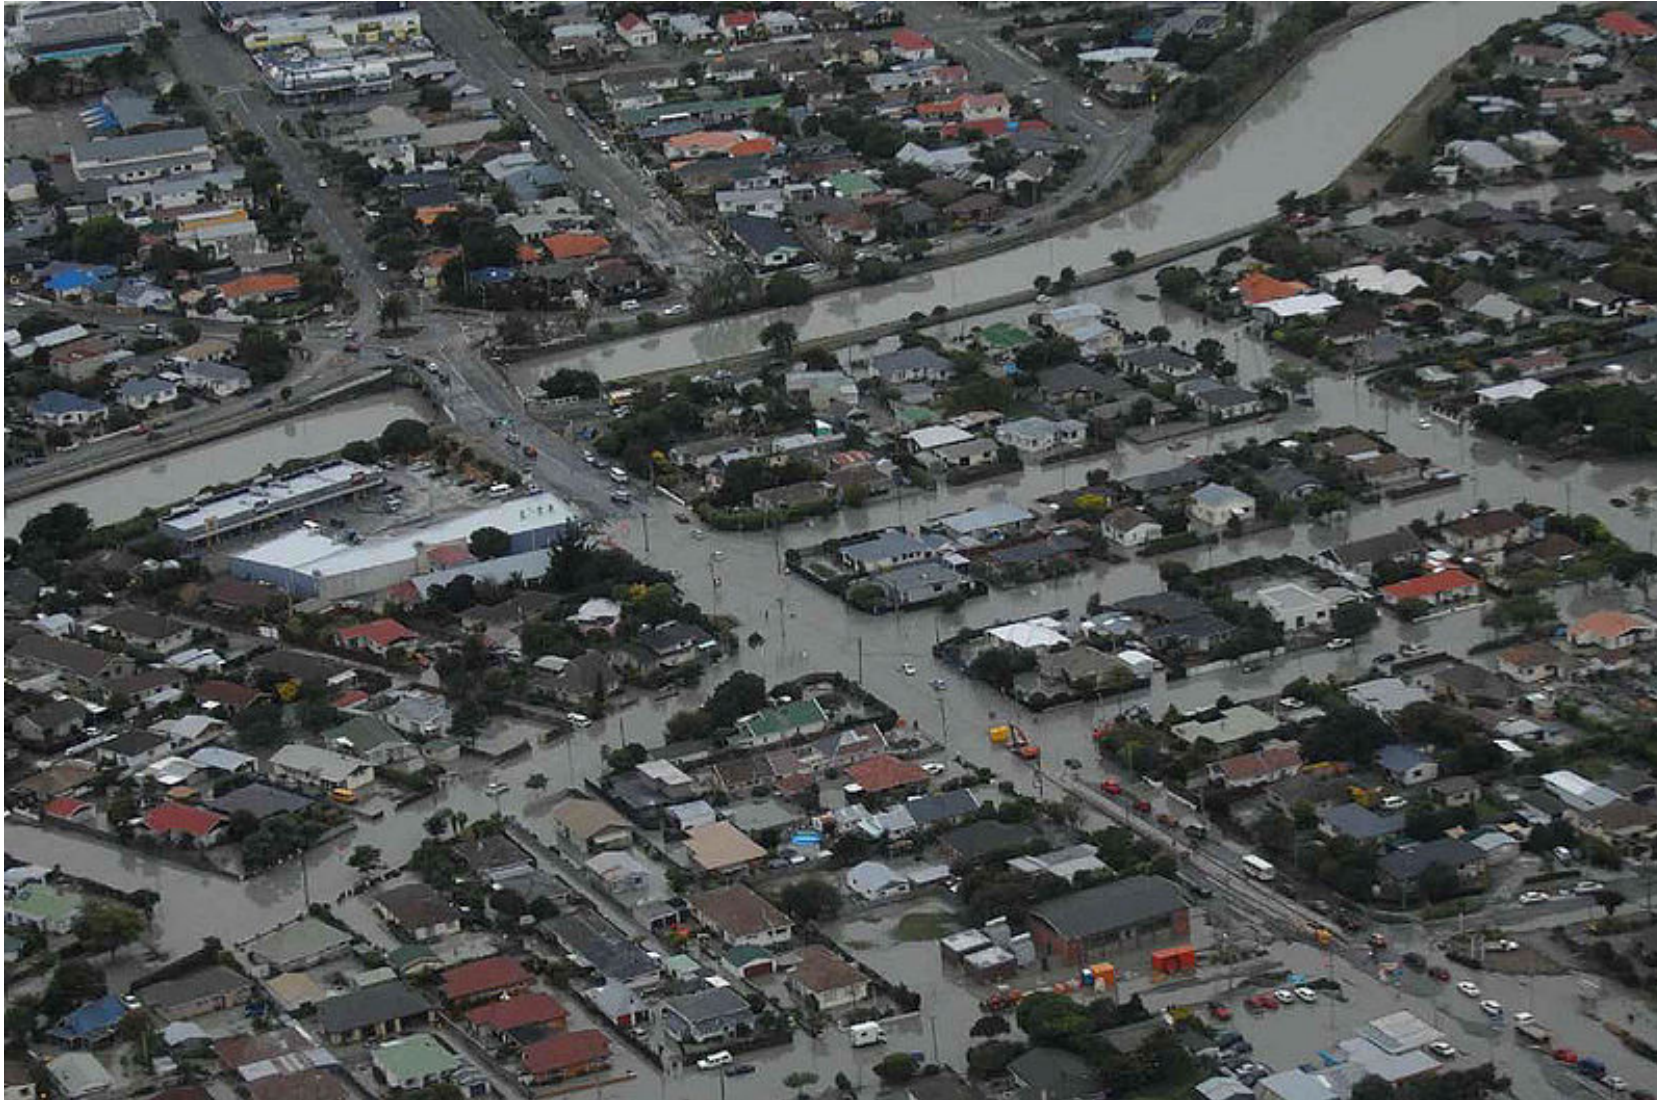
Widespread flooding due to liquefaction

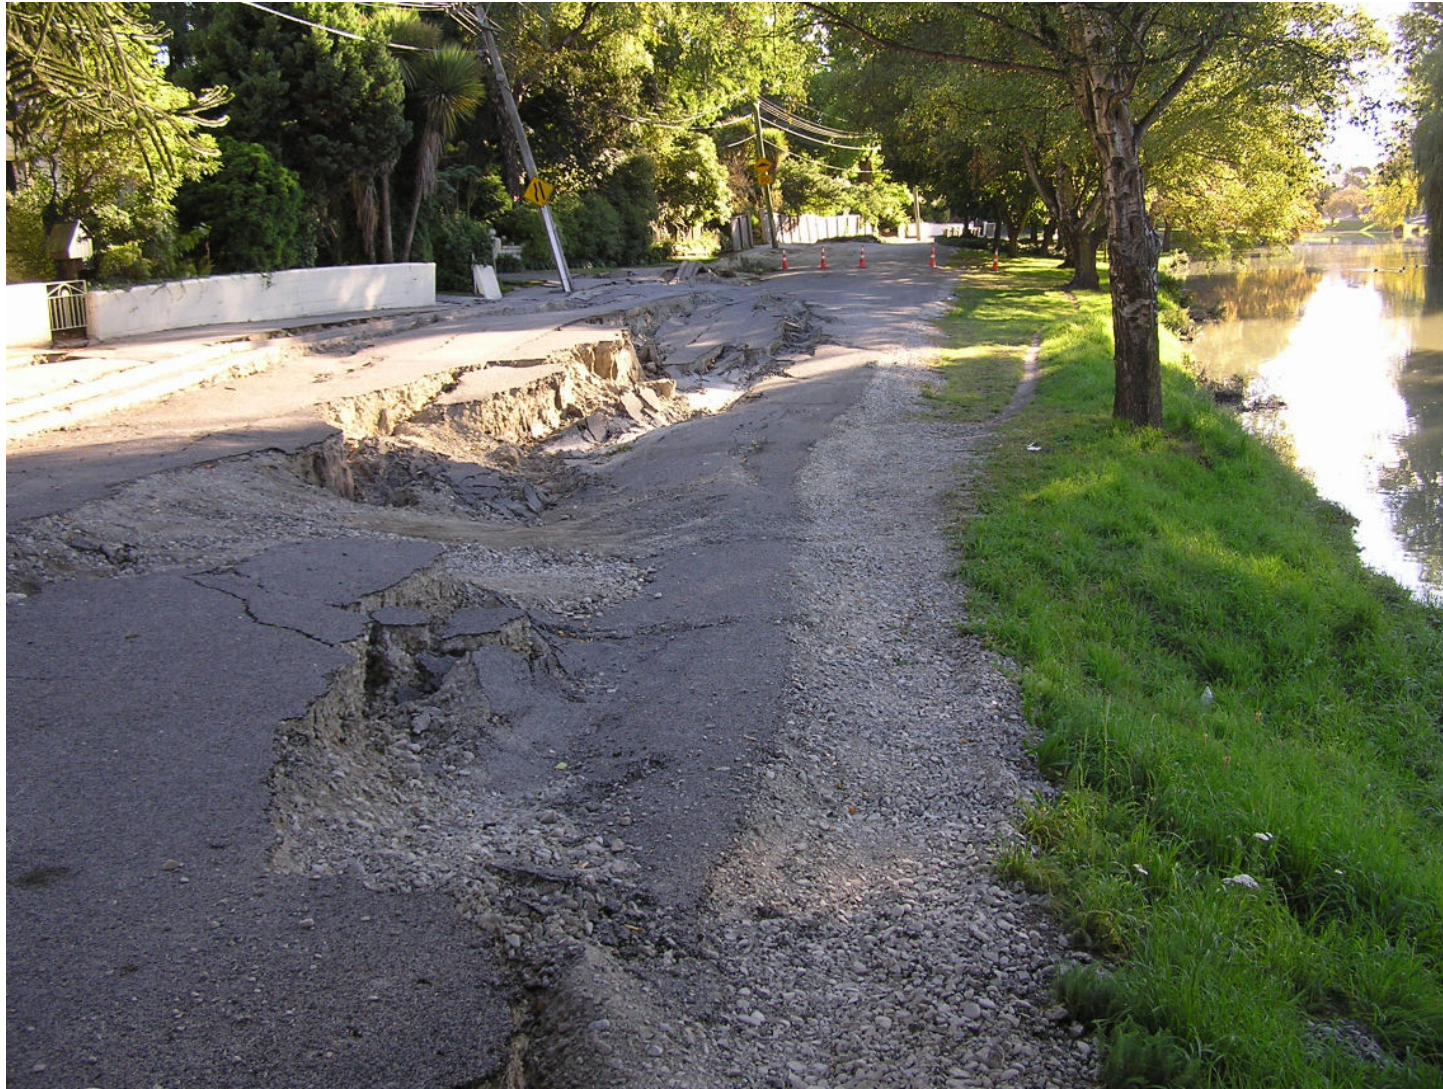
Lateral spread

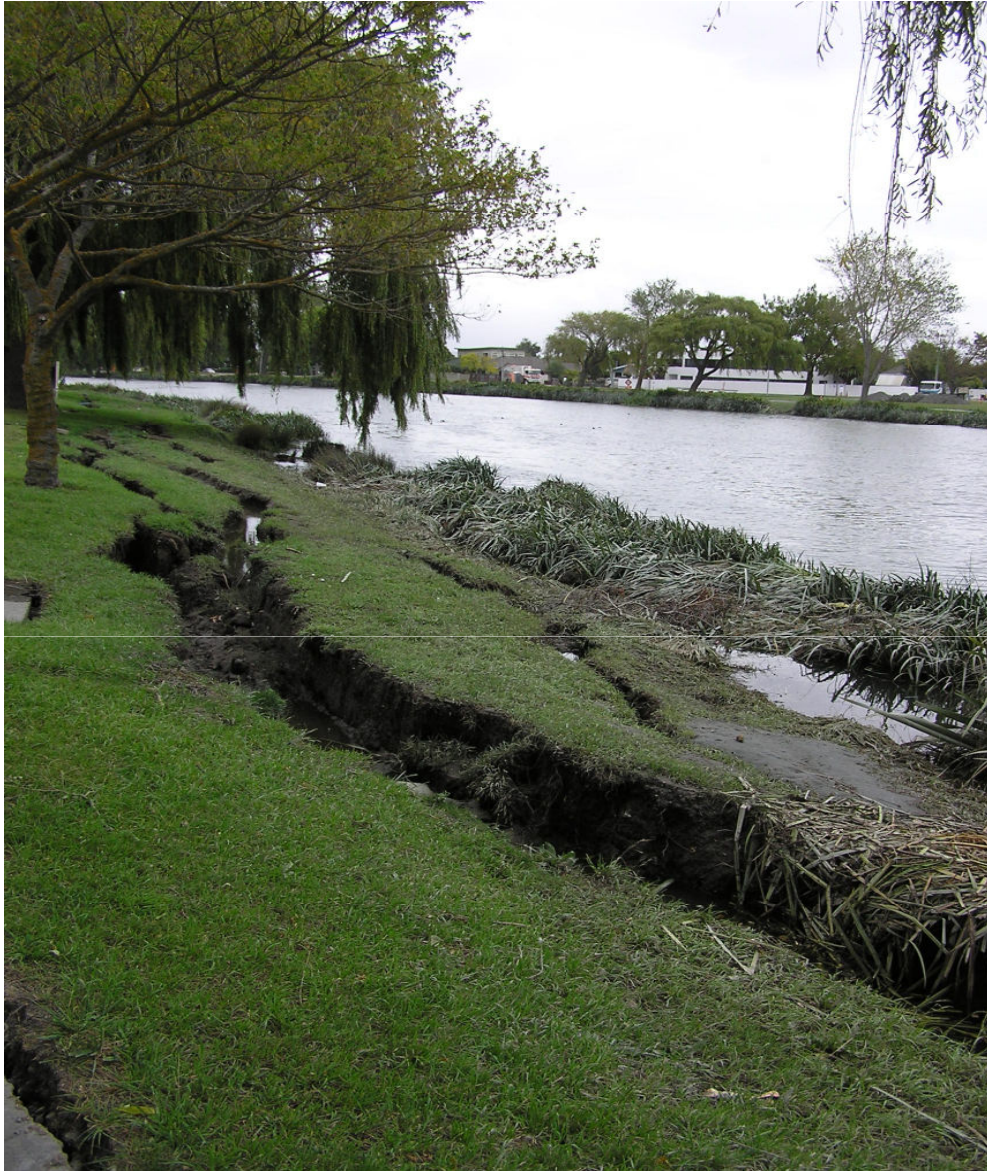
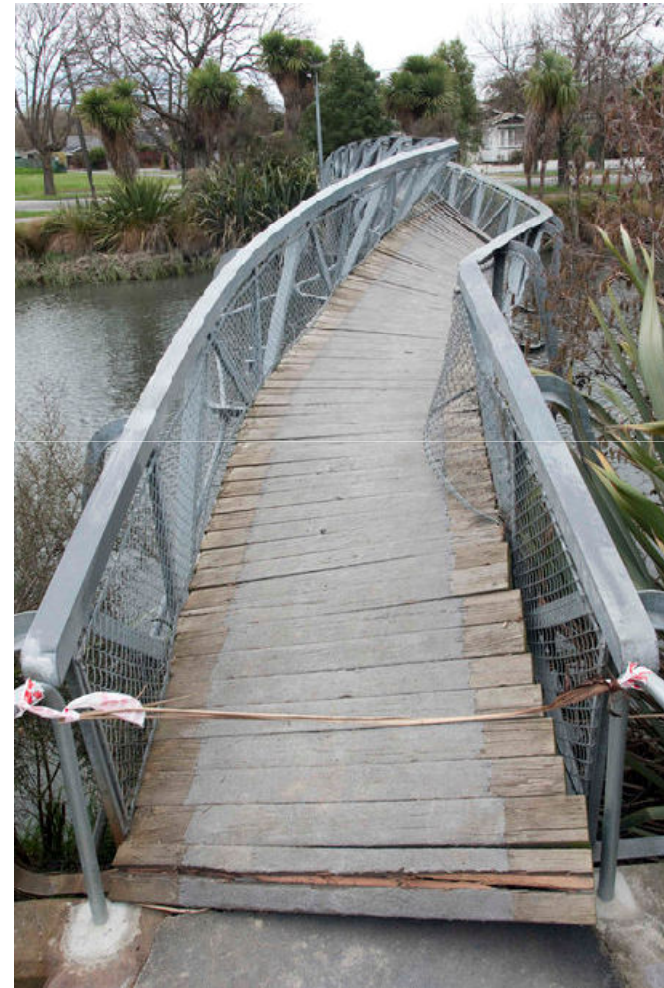
Lateral spread
