Rotorua Geothermal System

Intrinsic Values and Surface Features

ROTORUA DISTRICT COUNCIL

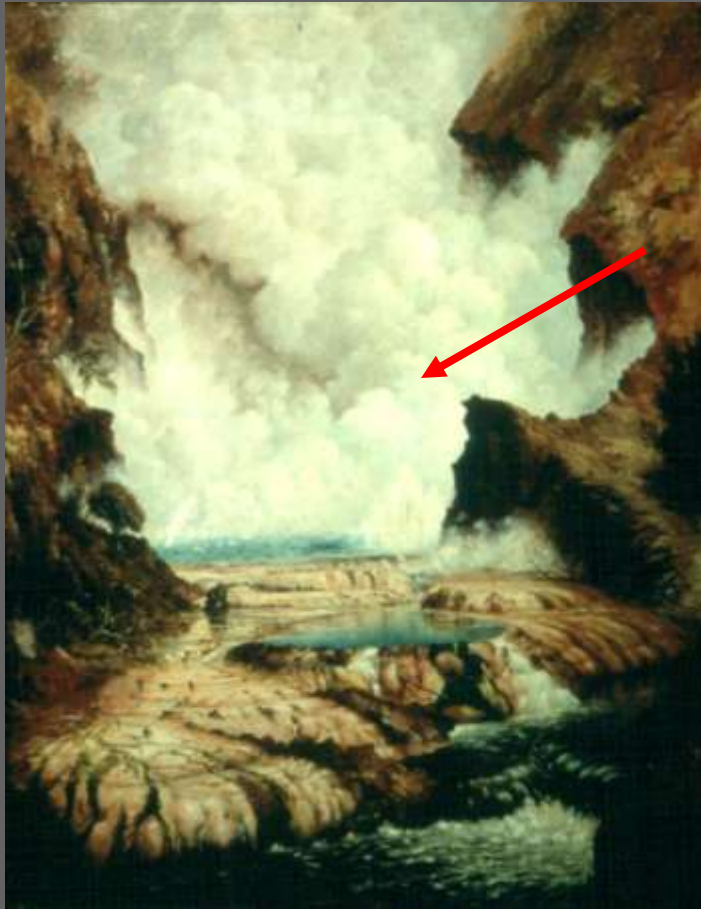
Champagne Cauldron
Wairakei (NZ)

Pre-development

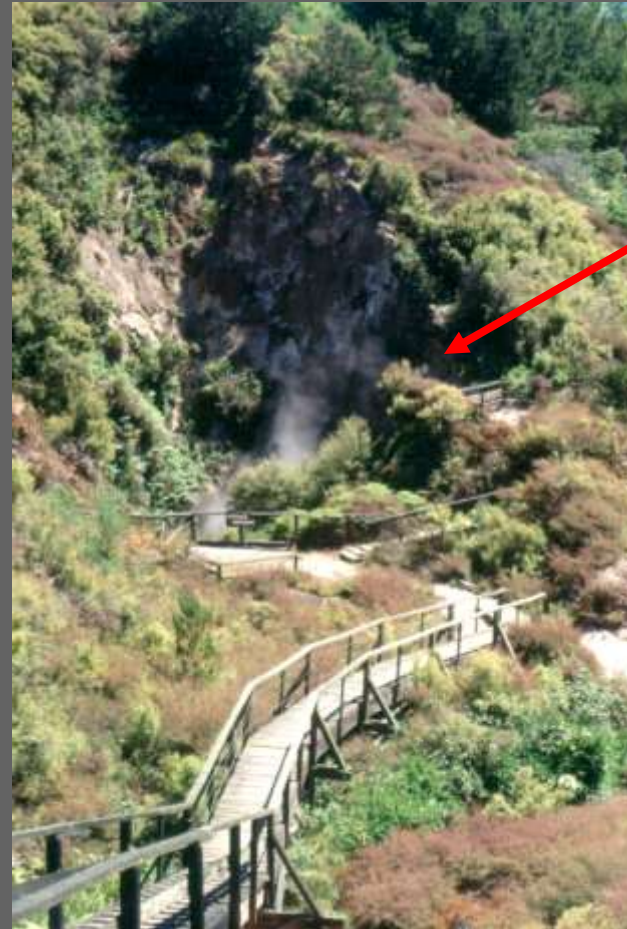
1997

Activity almost dead
overgrown with vegetation

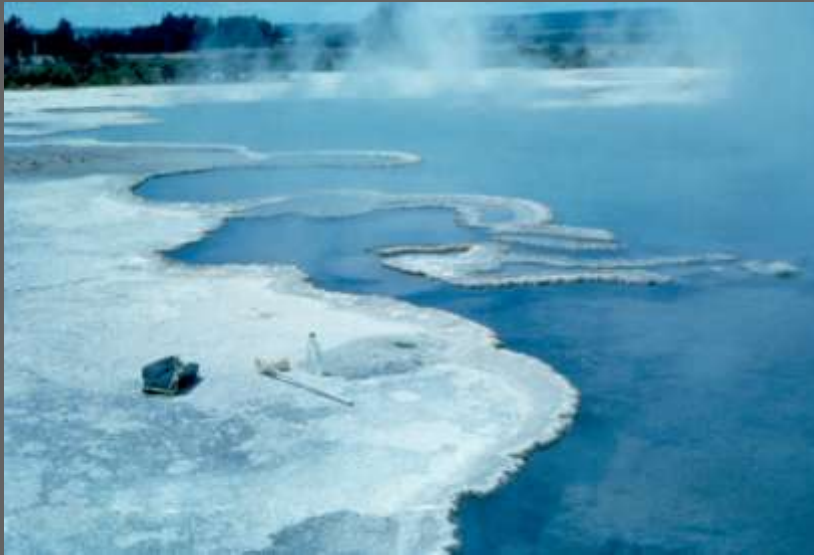
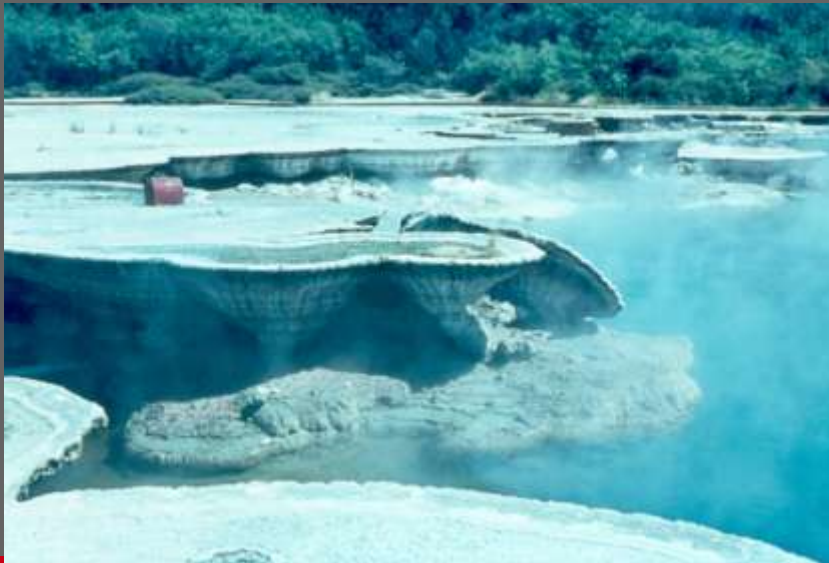
Ohaaki Pool (NZ)

before development (1952)
during well testing (1969)

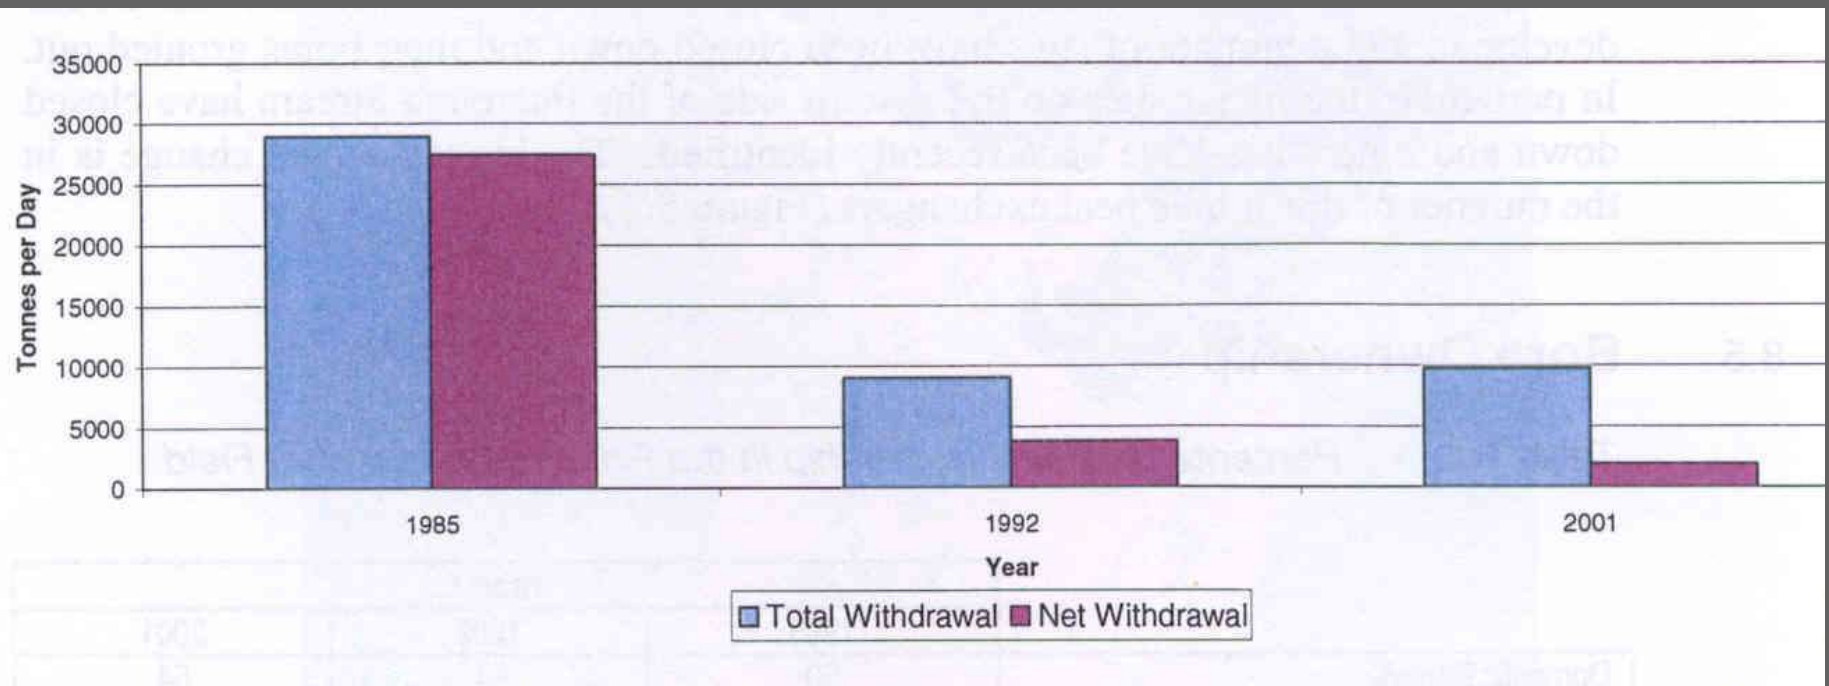
Monitor Bore - results

Ground water levels

Usage

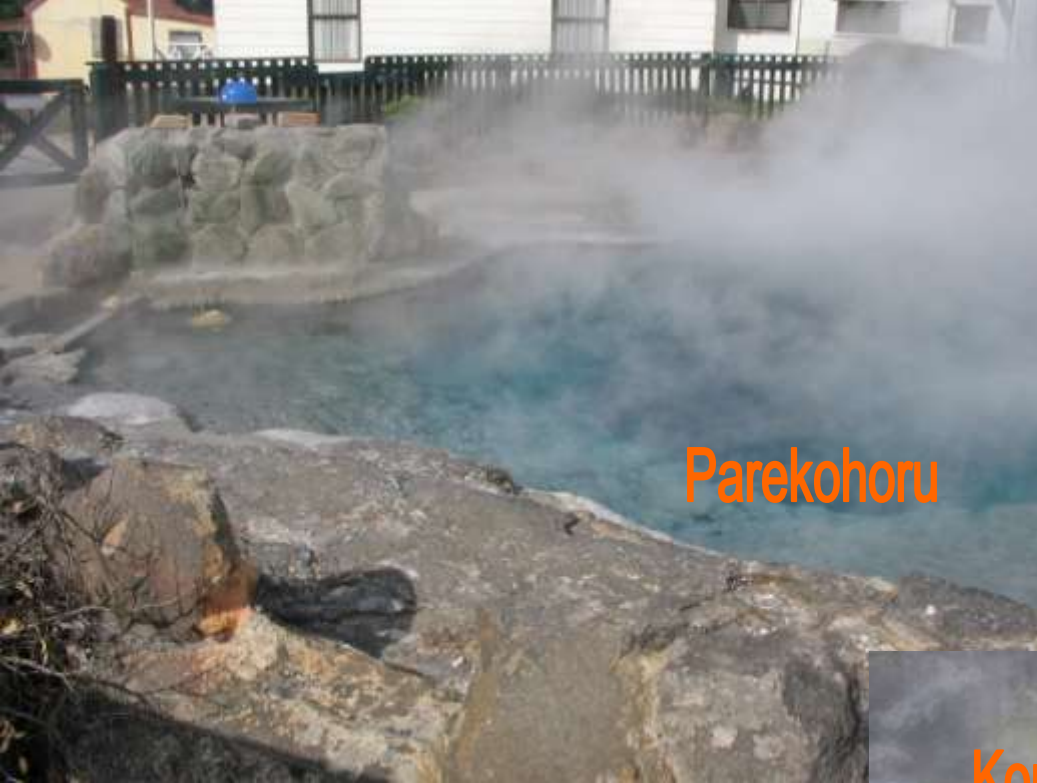
Parekohoru

Chloride Springs

some have recovered

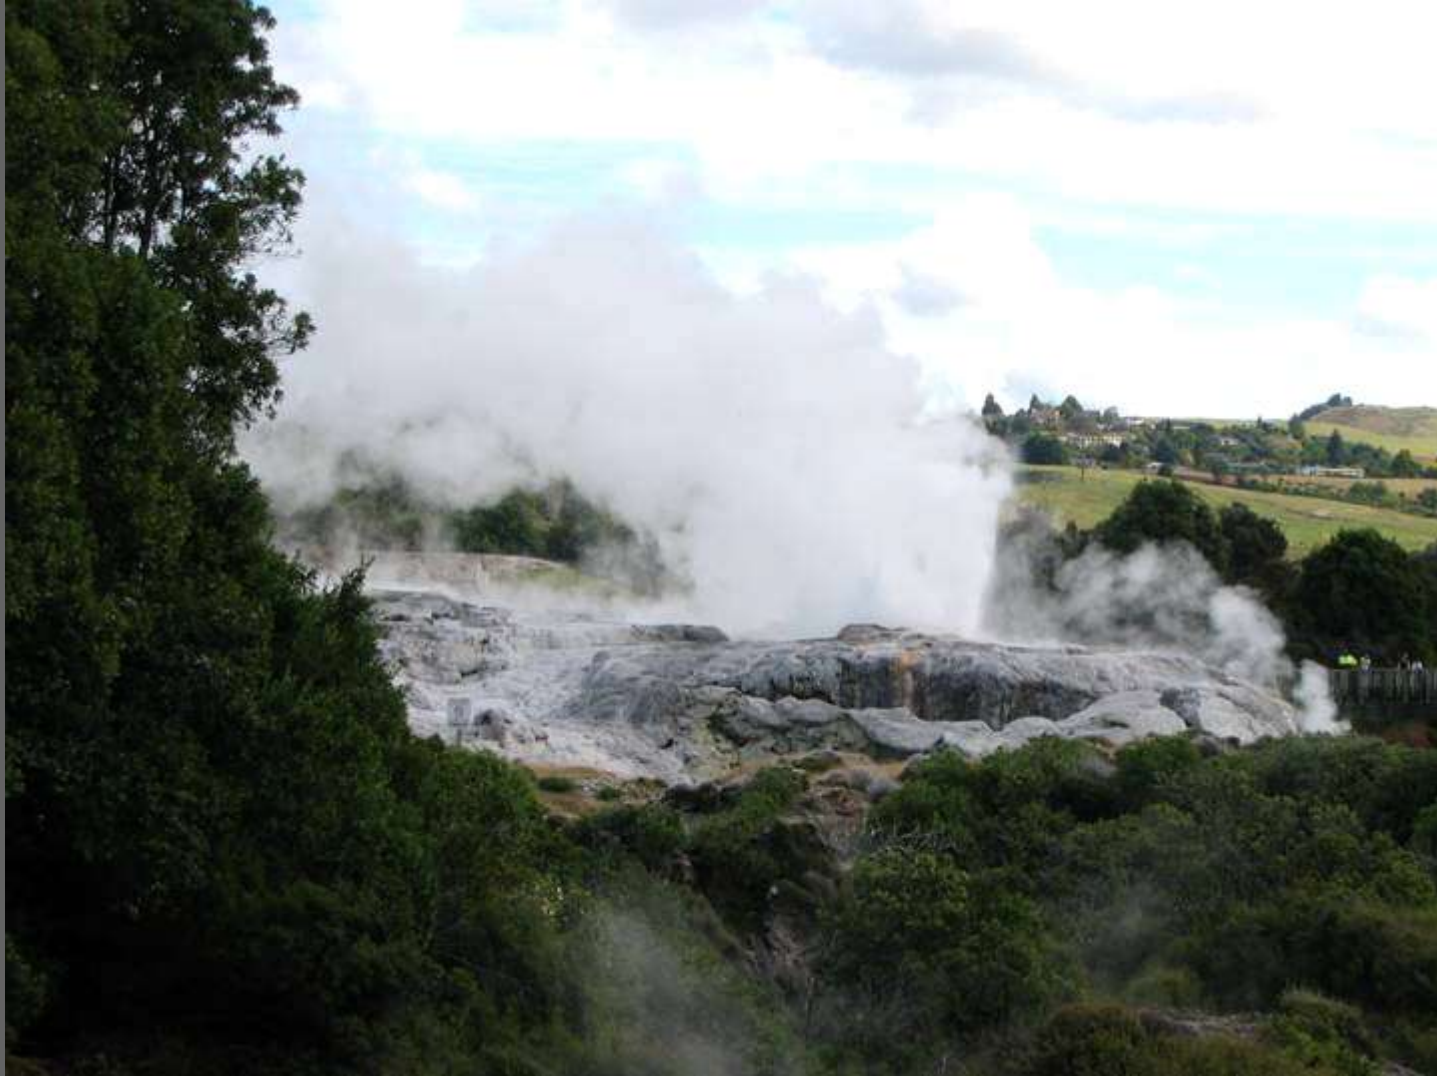
Korotiotio

Chloride Springs- Geysers
